Field Service Bulletin No. 22

Order No.: DD+DIS166.02E

ADC Solo
Type 5155 / 100

Replacement of a broken light barrier flag at the Cassette Opener

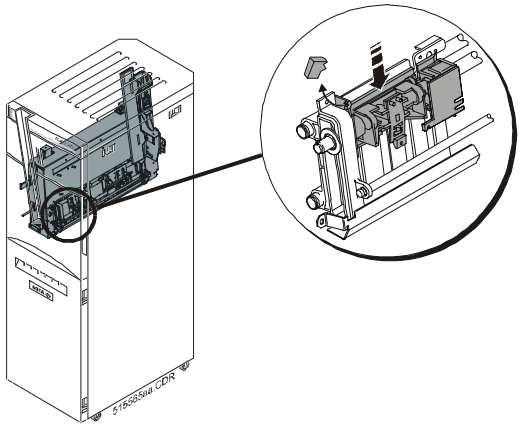
The light barrier flag (see figure beside) of the cassette opener may break when it touches the frame of the cassette opener.

The cassette opener (LHS) remains in the home position and is not moved to the middle position when the cassette holder is lowered manually.

Exchange the broken part.
Order number: **CM+9.5146.5911.0**

Spare part can be ordered separately. It is not necessary to order a complete cassette opener!
